3 Report on an Evaluation of
TILE DRAINS LAID WITH ORGANIC BLINDING MATERIALS

Skagit S.C.D., Washington //

Prepared by
R. H. Brownscombe, E. W. Cowley,
and R. E. Tuttle

52
May, 1959 //

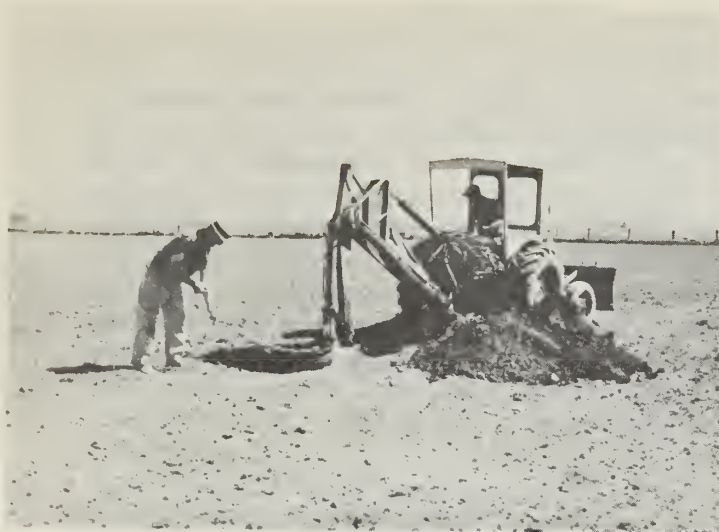
1. Tile probe and backhoe used for excavating tile inspection pit, Skagit Co., Washington.

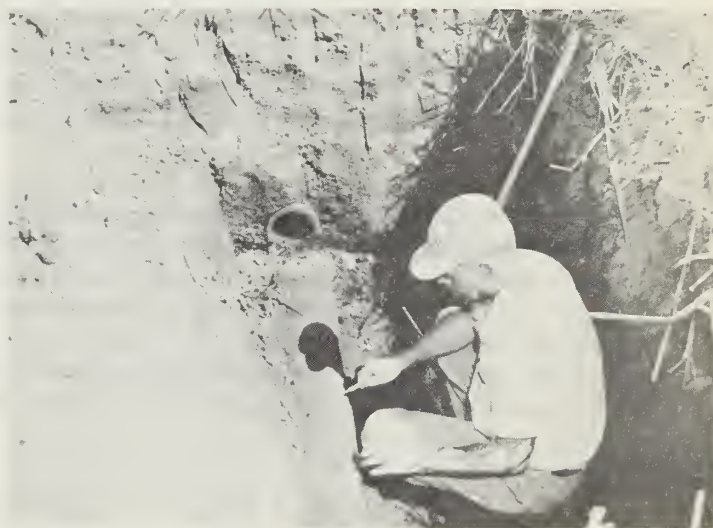
2. Examining tile line, filter material, and joint spacing.

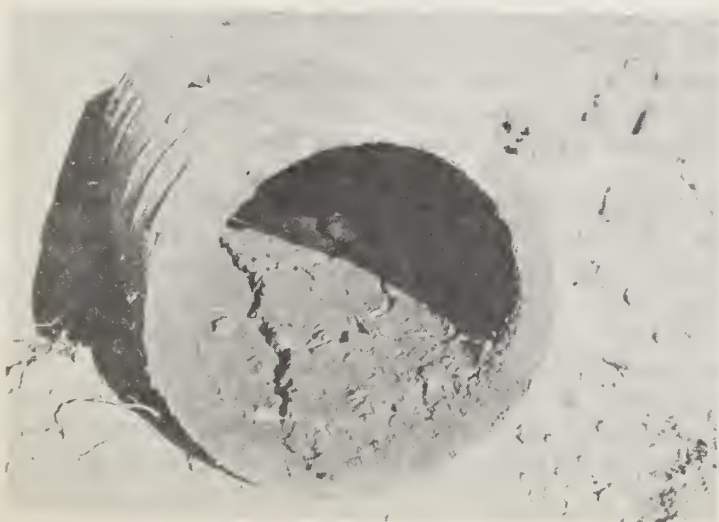
3. Deposit of organic muck in tile, showing shrinkage cracks.

Although there seemed to be little or no mineral soil deposited in most of the tile, a reddish or black muck was found in those tile which are submerged all or much of the year. This appeared to be an organic material, slimy when wet, with low dry-weight and high shrinkage (Photograph No. 3). There may be some mineral soil particles in this material, but it was not evident by visual inspection or feel. The deposit was principally on the bottom of the tile, inside, but at one site the muck was about 1/4 inch thick around the whole inside area of the tile. It was considerably thicker just inside each joint, forming a projecting ridge about 1/2 inch wide inside the tile. The same material was found between the tile at the joints.

Submerged tile lines contained a deposit of organic muck, as described above. Joints between these submerged tile were partially filled with the same organic material or other sediment. This deposit was found between the tile regardless of the space between the tile. In some cases, it had closed the openings on the lower half of the tile. The deposit on the inside wall of the tile was thickest close to the joint; in fact, there was a ring of this thicker deposit at each joint of submerged tile. No joints were found, however, which did not indicate some openings for water around the upper half of the tile. About 5 or 6 joints were inspected at each site, representing roughly 2% of the total number of tile joints in these lines.

2. Analyze the organic muck observed within the submerged tile lines to determine how much, if any, mineral soil is present and the nature of the organic material. This may require microscopic examination and ignition tests.
3. Make a few selected field examinations to determine whether such deposit will form in tile which has an adequate outlet, in the same soils as those in this study.
4. In subsoils of sand, sandy loam or other unstable soils which have a relatively high piping hazard, use the following construction to prevent silting:

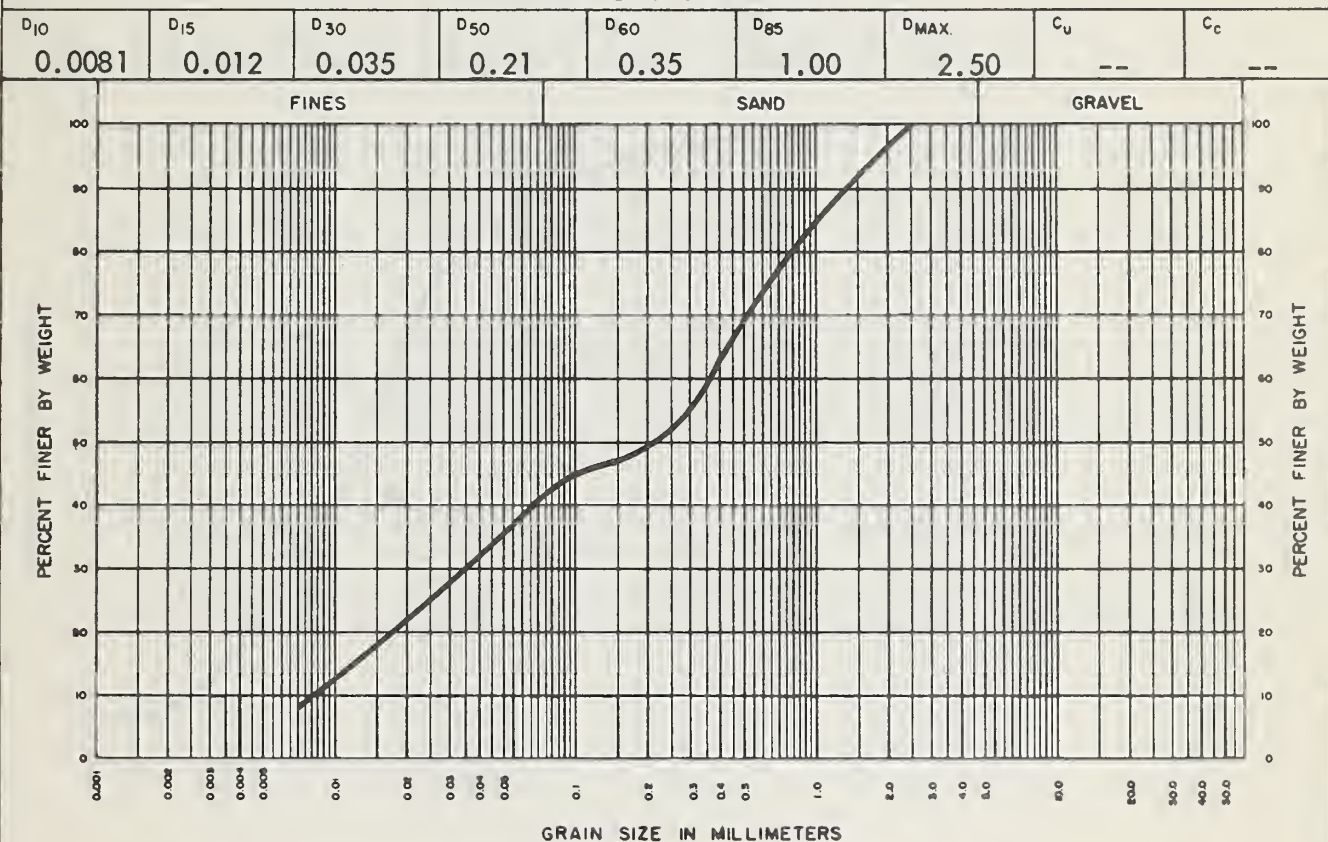
1: SYMBOL	2: DESCRIPTION Dark brown organic silty sand. Snohomish silt loam.
-----------	---

pH = 5.7

Non plastic (indicated by field identification test).

Grading curve may be in error due to high content of organic material.

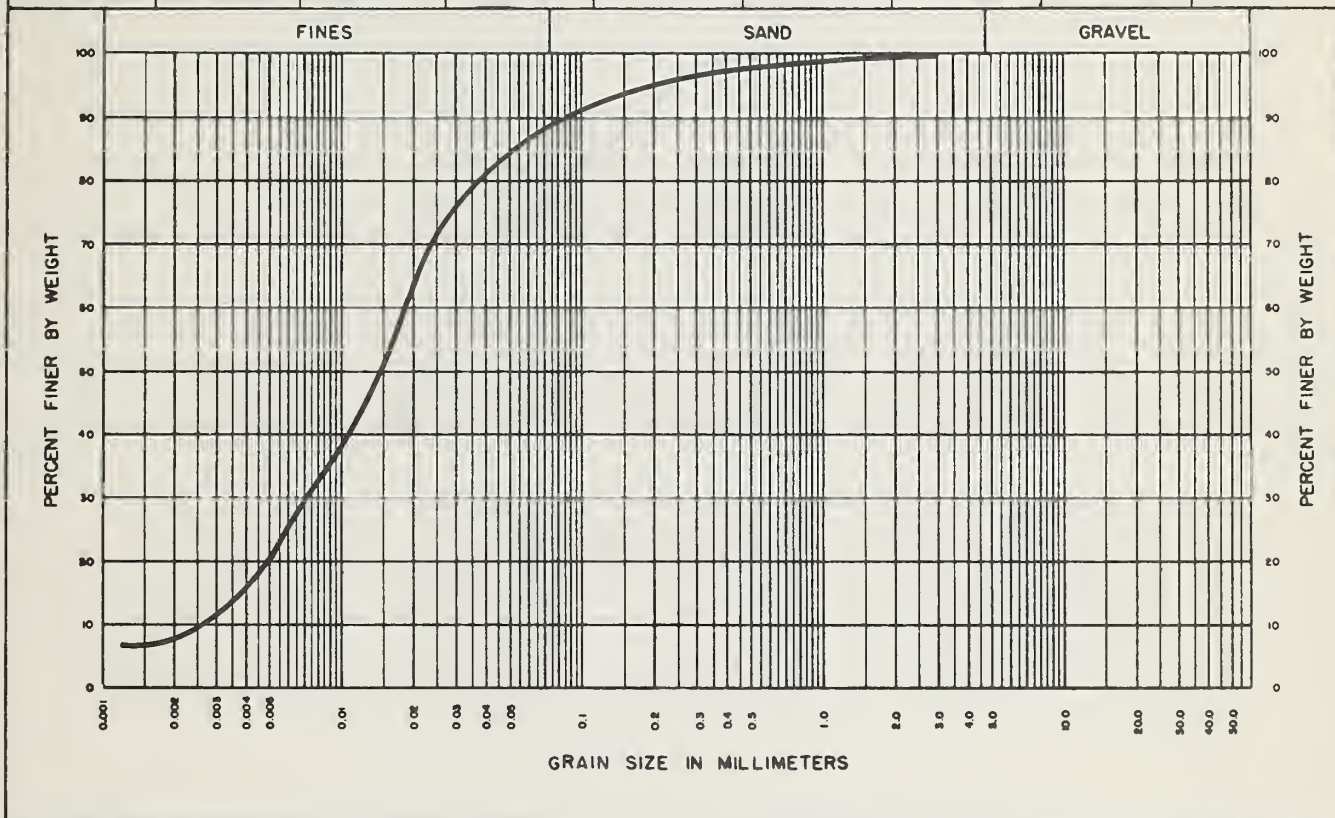
1: SYMBOL	2: DESCRIPTION Light gray silt Sumas silt loam
------------------	--

8: REMARKS <p style="margin-left: 40px;">pH = 4.9</p> <p style="margin-left: 40px;">Low plasticity (indicated by field identification test).</p>
--

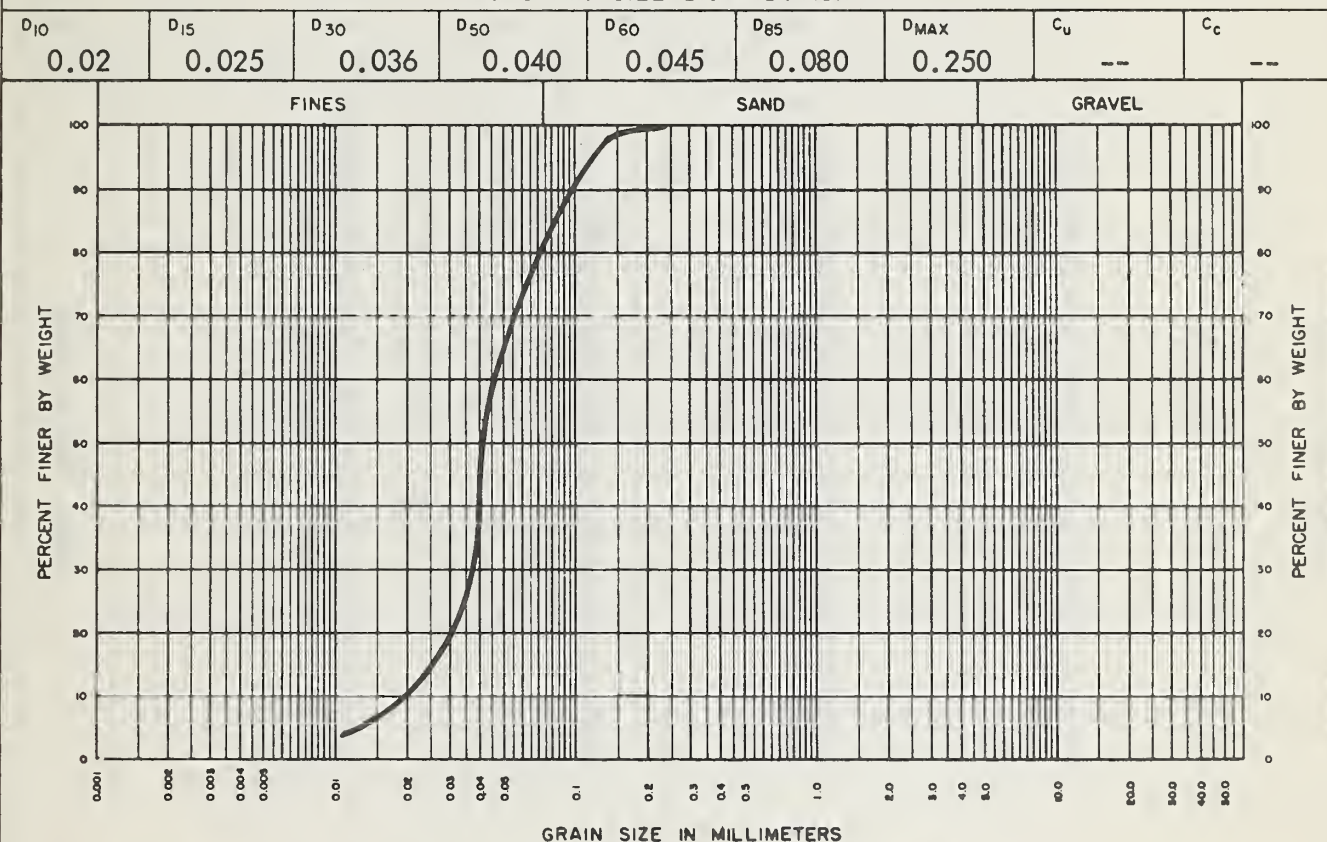
Puget fine sandy loam and Puyallup silt loam, both from the Wold farm, were rather poorly graded and appeared to have considerable piping hazard. A sample was taken of Puyallup silt loam subsoil near a section of tile line which had "silted up" partially, and another of the deposit within the tile. The two grading curves appear to indicate that the particle size range constituting the greater part of the material carried into the tile was from 0.02 to 0.05 mm, which is silt by the USDA classification. The two samples on this farm had the lowest uniformity coefficients of any of the samples, and were therefore the most poorly graded. They had a high percentage of silt and fine sand. Both are non plastic and appear to be low in organic material.

1: SYMBOL	2: DESCRIPTION Gray sandy silt Puyallup silt loam
-----------	---

pH = 6.4
